## **Incidence of Boiler Furnace Explosion at RCF Trombay Unit**

### **Incident**

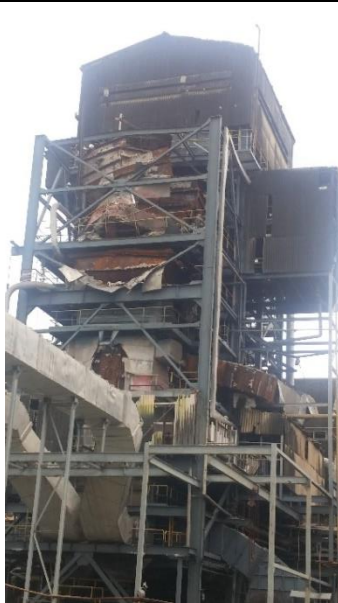
On 2<sup>nd</sup> July 2016, there was an explosion in Boiler no. 2 at RCF Trombay, which was getting ready for start-up after planned maintenance. The explosion resulted in 3 fatalities and 5 injuries. The investigation concluded that one of the boiler trip valves (out of total eight) was partially open though it was indicated to be in closed condition at panel. A momentary opening of fuel gas main valve by the operator to check the leakage in the flange resulted in formation of explosive mixture inside furnace of the boiler due to the passing valve. Operating procedure has been modified to prevent recurrence of this incident.

The root cause for the explosion was due to formation of explosive mixture in the furnace due to passing of one of the burner trip valves of the boiler. There are eight burner trip valves in the boiler which gets closed upon shutting down the boiler as per safety interlock. Upon investigation it was observed that burner trip valve No. 6 was found partially open, though all eight trip valves were marked in closed condition on DCS panel. The momentary opening of the main gas valve for checking the flange leakage led to entry of the fuel gas into the furnace in spite of the bleed line in the fuel line remaining open to atmosphere. The source of spark causing the ignition could not be ascertained, and could be possibly a spark generated from some work initiated by the contract workmen at the manhole cover who were clearing the area/collecting the tools after completing the job.

- Boilers, furnaces and reformers to be charged with fuel gas only when furnace draft fans are put into operation. Standard operating procedure modified accordingly.
- Fuel gas line leak test to be strictly done with nitrogen.
- Proper interdepartmental communication to be ensured between maintenance supervisor and control room and work area to be cleared of contract workmen before initiating start-up activities.
